Pre-Purchase Building Inspection Report

Address: 221 Baker Street, Morphett Wile, SA, 5162

Date/time of inspection: 25th of September 2021 10.00 am – 1.00 pm

Report number: 12/9/21

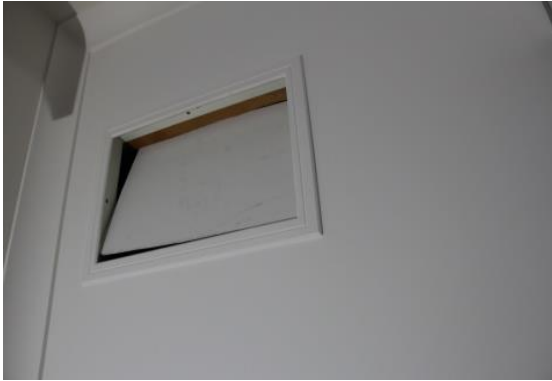
Interior Roof space: **some of it was inaccessible. The manhole was smaller, than allowed to be used by Australian Standard 4349.1-2007 to safely inspect the Interior roof space.**

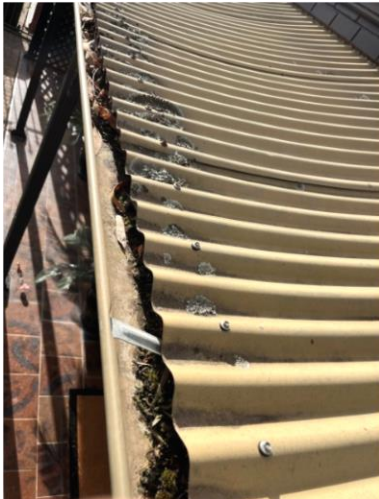
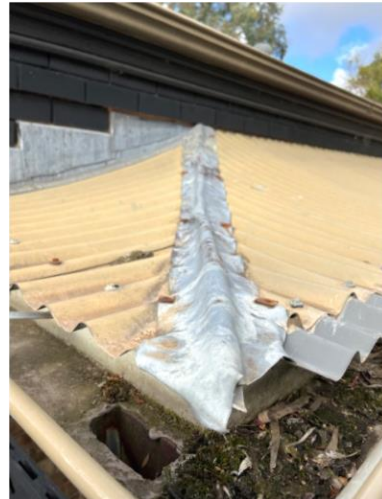
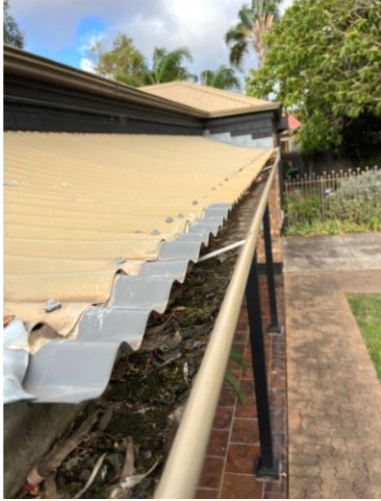
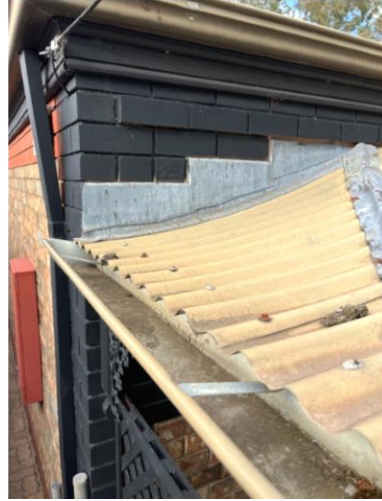
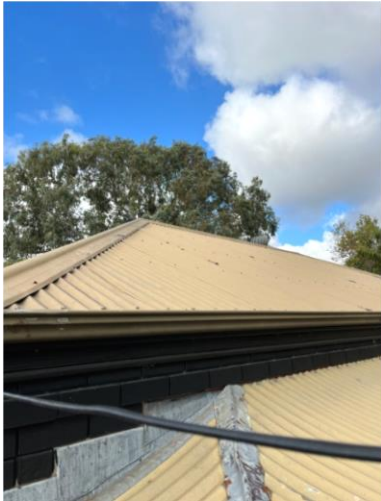
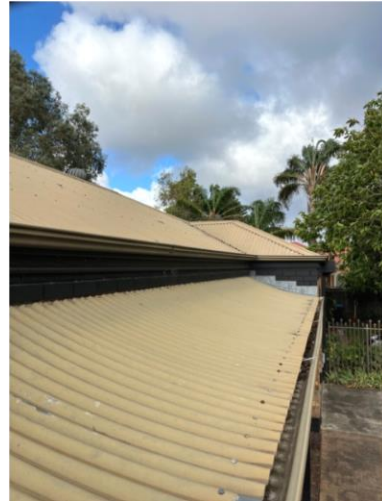
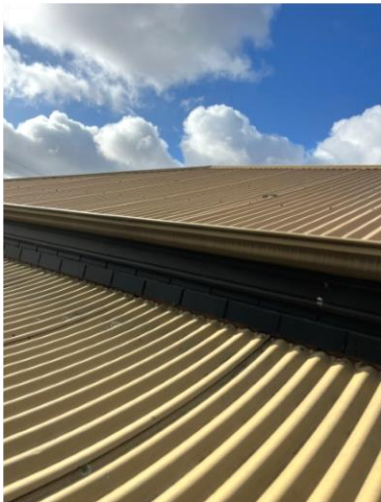
Colorbond roof at the time of inspection had some rusty screws and poor workmanship on verandah roof. A correction is required by a licensed roofer or carpenter.

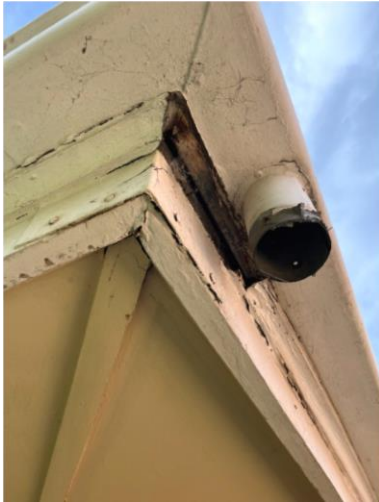
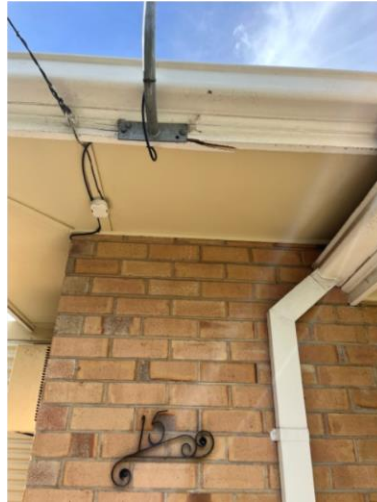
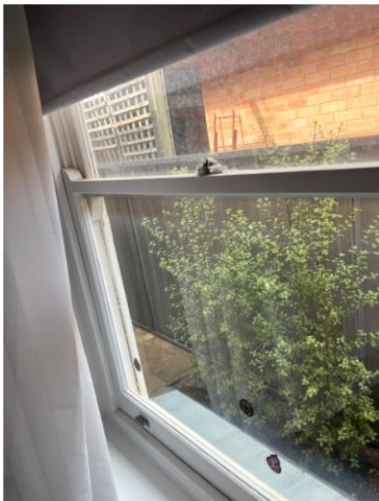
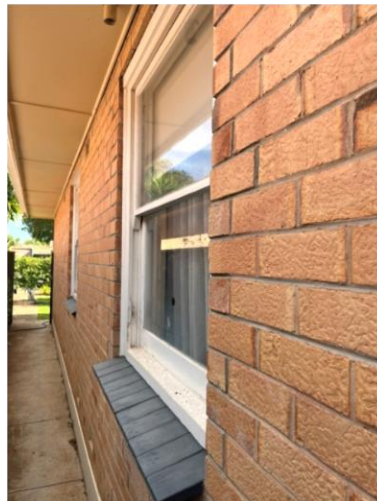
Details: At the time of inspection some deformation of a fascia board in several places around the property was visible. It's a major defect in need of correction by a licensed roofer or carpenter. At the time of inspection a representative number of windows were checked. Some of them in Bedroom 1 and Bedroom 3 were not opening at all, because wood in them became deformed. It is a major defect a correction is needed by a licensed carpenter.

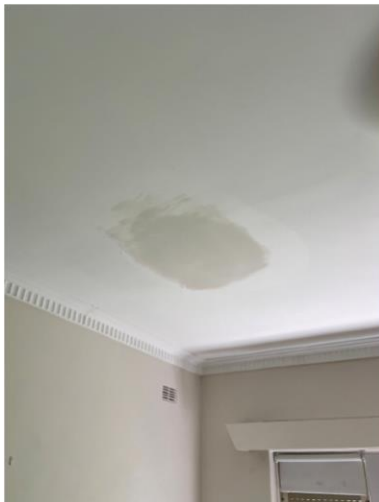
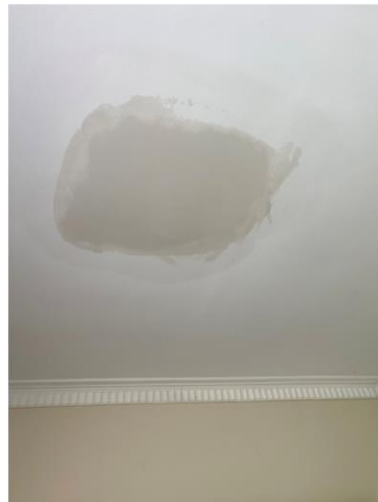
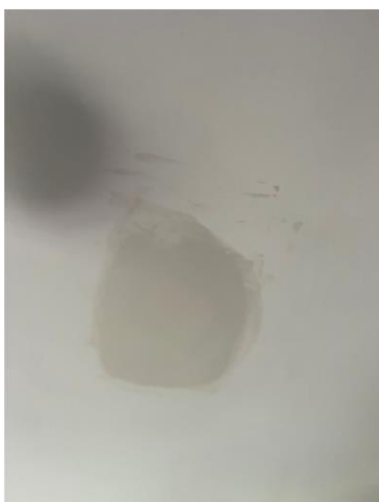
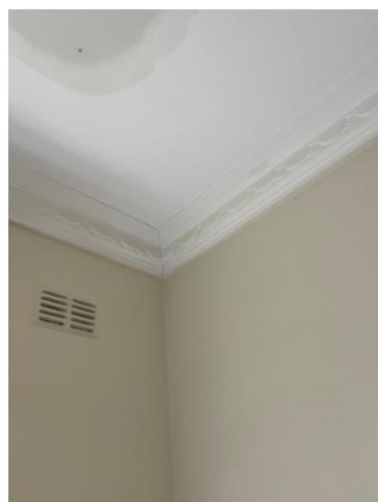
Details: Water staining was observed to the ceiling plaster in the home. Water staining is indicative of moisture ingress into the area. This should be repaired as soon as possible as excessive moisture can cause conditions conducive to timber pest activity as well as leading to the deterioration of internal elements. An investigation (by a competent person e.g. a licensed roof plumber) is recommended ASAP to determine the method and extent of any remedial required and associated costs.

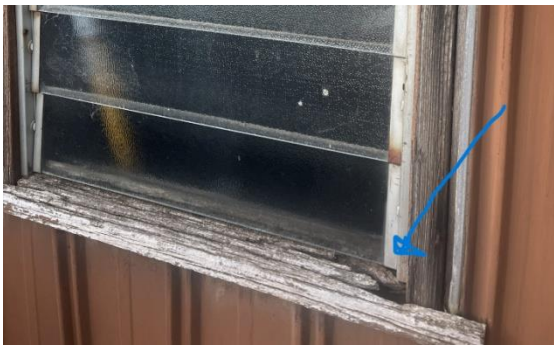
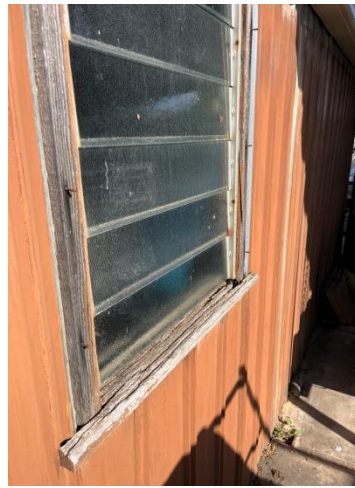
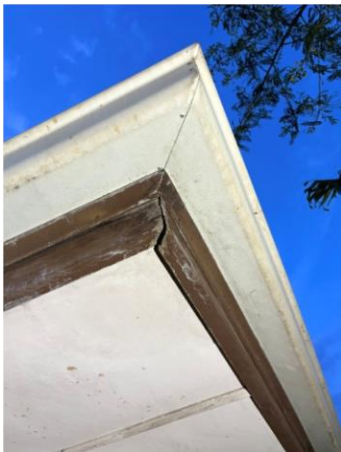
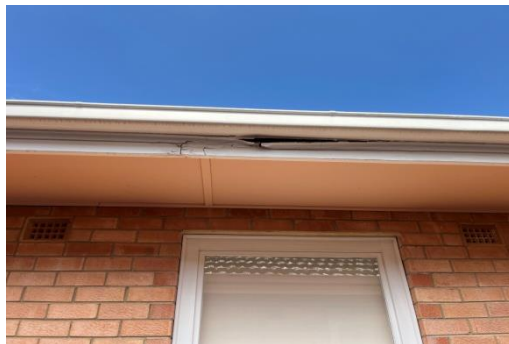
Details: Complete wood decay was observed at the time of inspection in the shed that was present at the property. A correction by a licensed carpenter is needed. At the time of inspection rotten wooden fascia was observed in several places around the property.

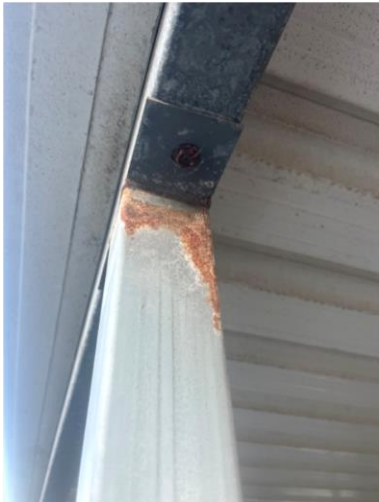
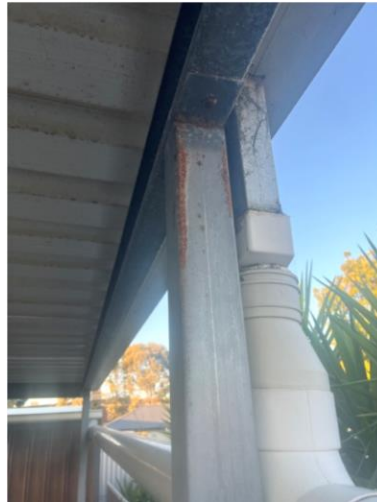
Details: There was some corrosion observed to framework that requires cleaning up and painting to prevent further deterioration. These structural components need to be assessed once they've been cleaned up as to their serviceability. An investigation (by a competent person e.g. a steel fabricator) is recommended to determine the method and extent of any remedial work required and associated costs.

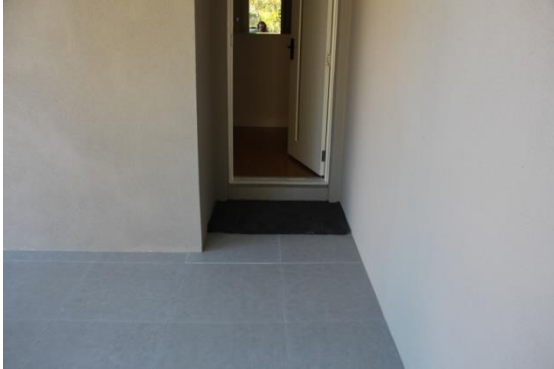
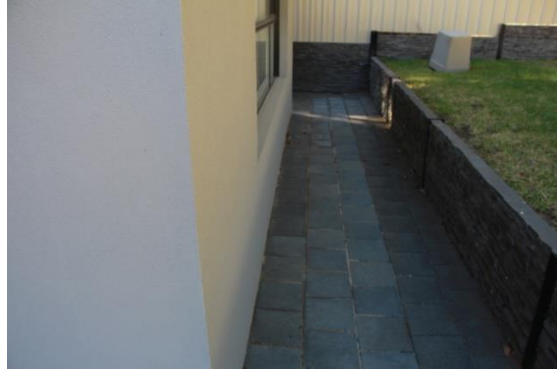
Details At the time of inspection it was noted that all ventilation in the (old part of the house) were rendered over, that left double brick walls and crawlspace under wooden floor without any ventilation. This considered a major defect, a correction is needed by a licensed ventilation specialist.

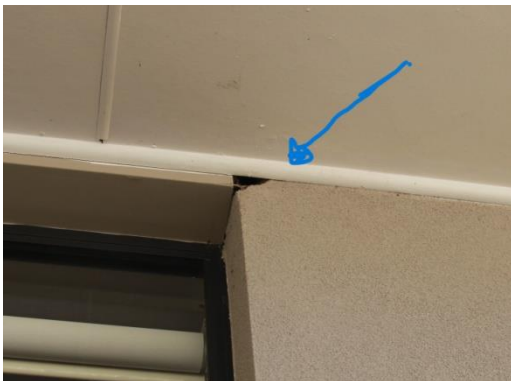
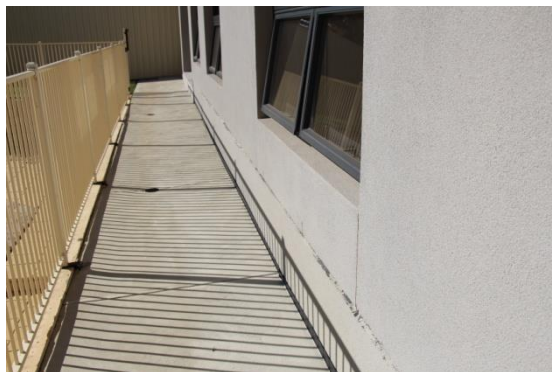
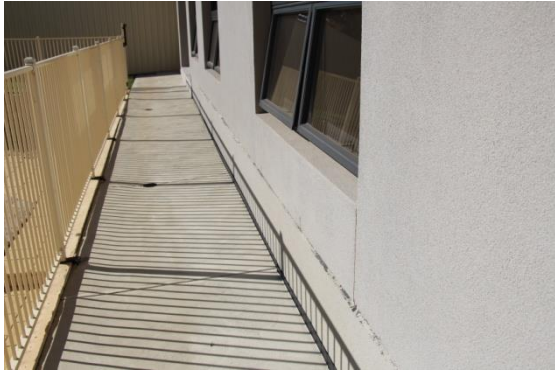
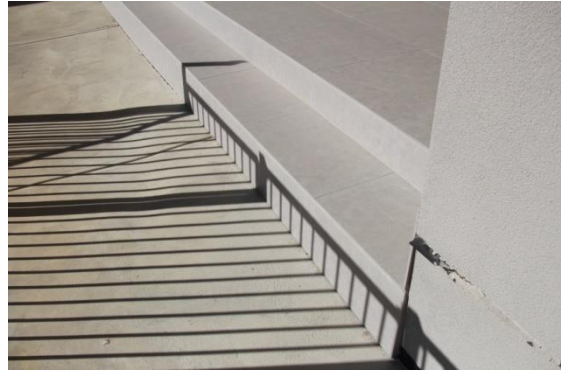
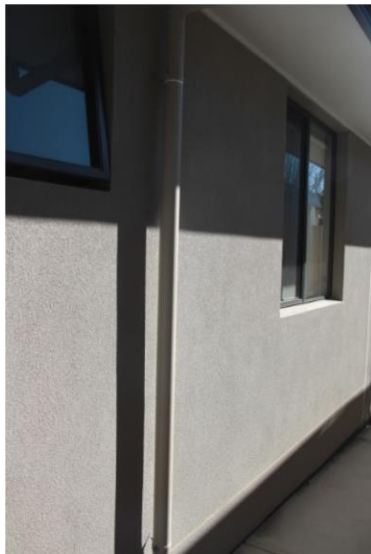
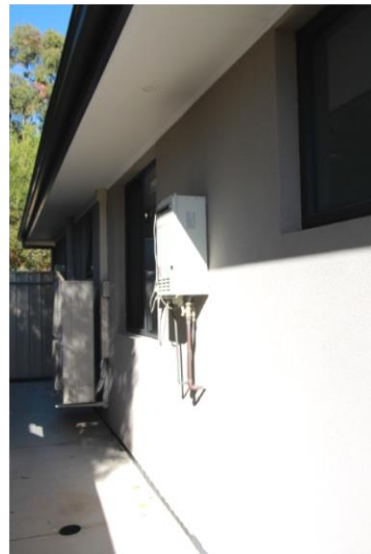
Details: At the time of inspection a poor workmanship was noted around the property (render with holes on the exterior wall). This is considered as a minor defect, correction is needed by a licensed plasterer.

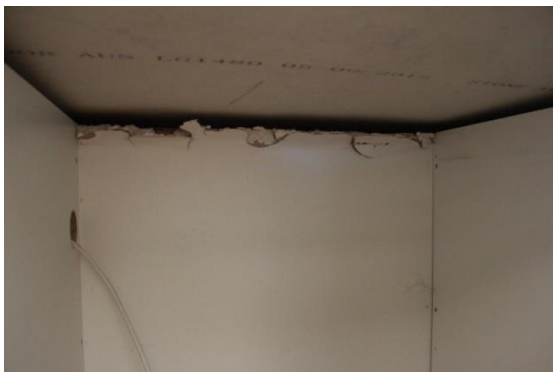
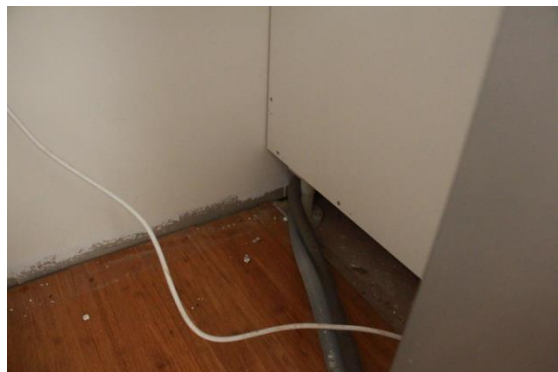
Details: Some bad smells were detected at the time of inspection (in the old part) of the property. Mainly in the pantry, wardrobe closet, second bathroom, parts of the kitchen. Smells were coming through, cracks in render and plasterboard partitions. It was recommended that ventilation for the enclosed space in double brick walls and underfloor crawlspace should be arranged by a licensed ventilation contractor.

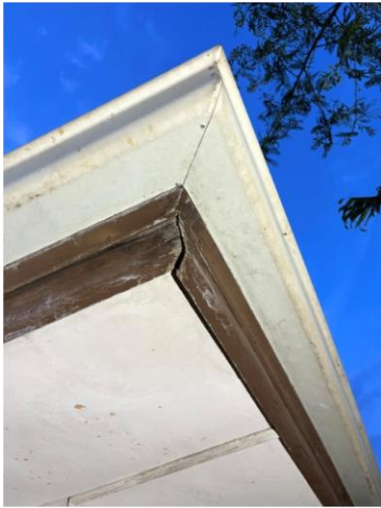
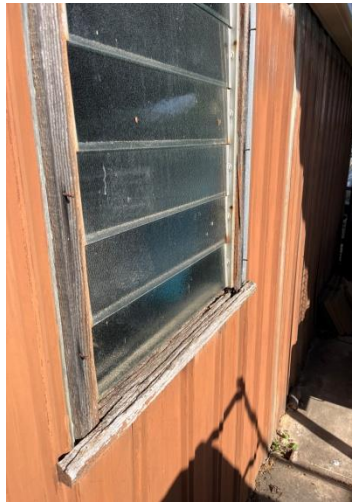
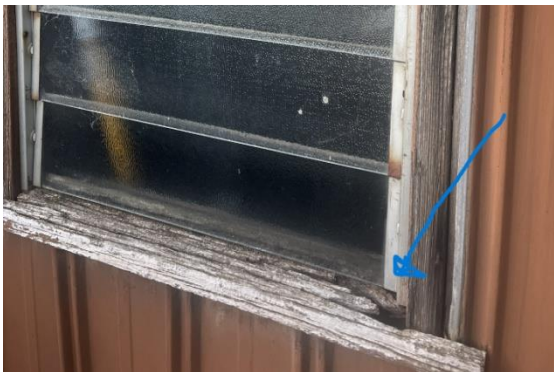
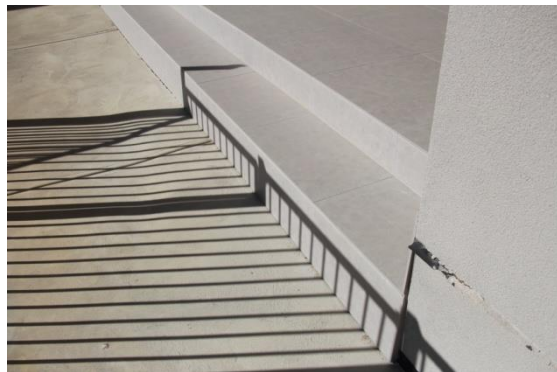
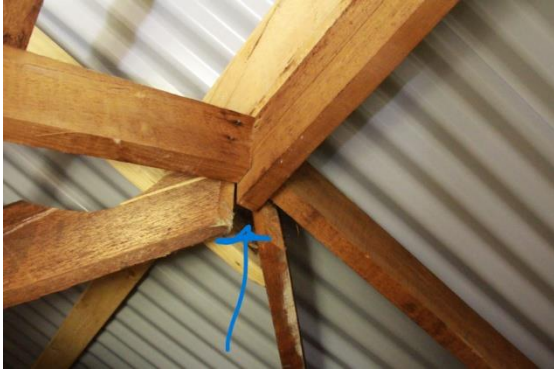
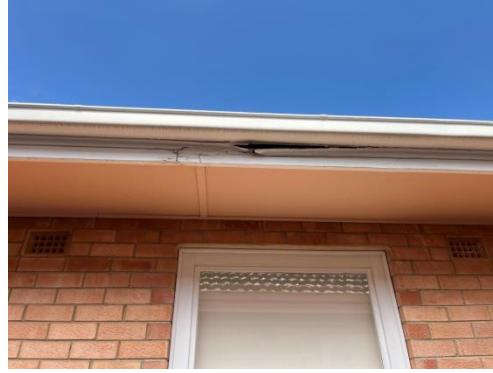
Details: 1. Fascia board was heavily rotten and threatens to fall down in several at the time of inspection. 2. Shed: It was observed that a piece of wood that acts as a window sill is completely destroyed by moisture intrusion. At the time of inspection the shed window had no support from that window sill. It could fall at anytime. 3. One of the rafters was out of place at the roof pitch. A correction was recommended by a licensed roofer or carpenter.

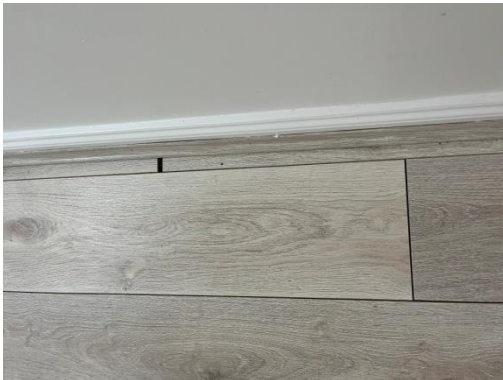
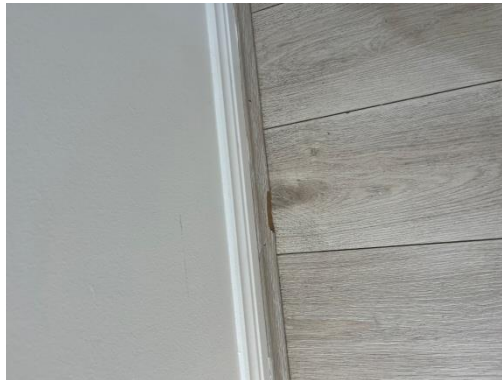
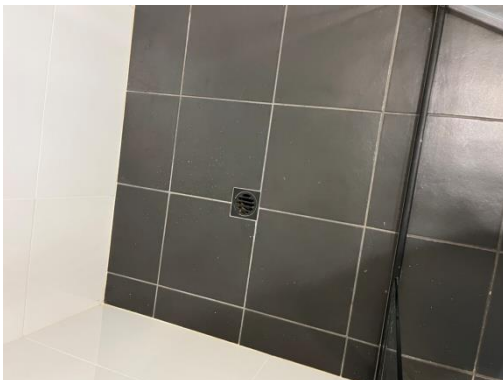
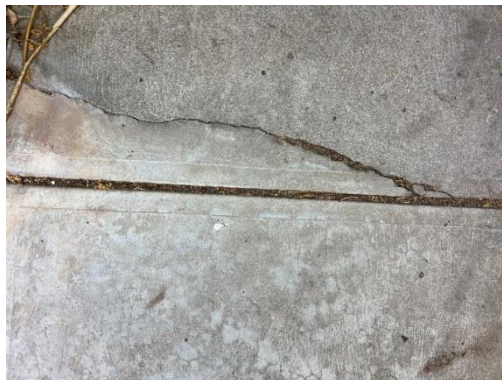
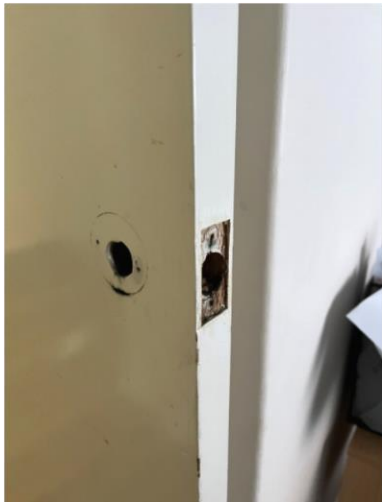
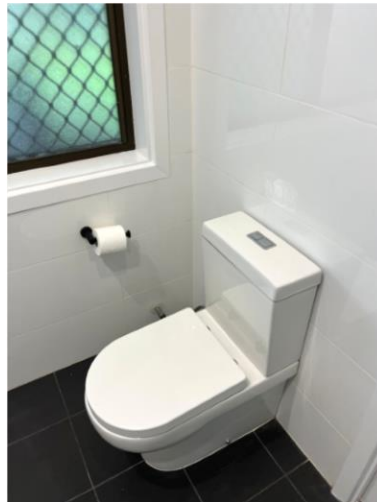
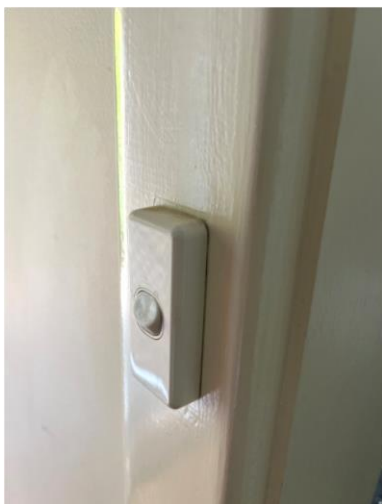
Defects 1. At the time of inspections some minor defects were observed on the floating floor in the main living room. A correction was recommended. 2. A shower drainage trap cover has lost its color due to corrosion in ensuite shower, it was recommended for that cap to be changed. 3. At the time of inspection some minor cracks were observed on the main driveway. 4. At the time of inspection 2 doors to bedroom 2 and bedroom 3 were missing door locks. 5. The toilet wasn't properly flushing at the time of inspection. The flushing mechanism wasn't functioning correctly. A correction was recommended by a plumbing contractor. 6. At the time of inspection some receptacles had cosmetic defects. 7.

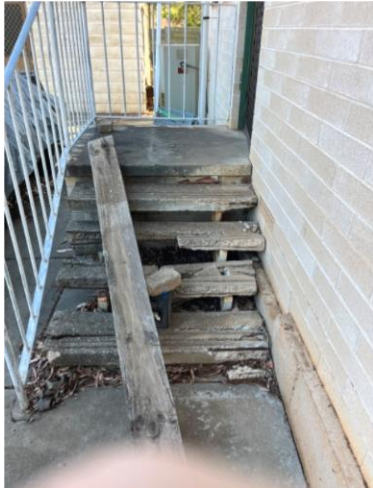
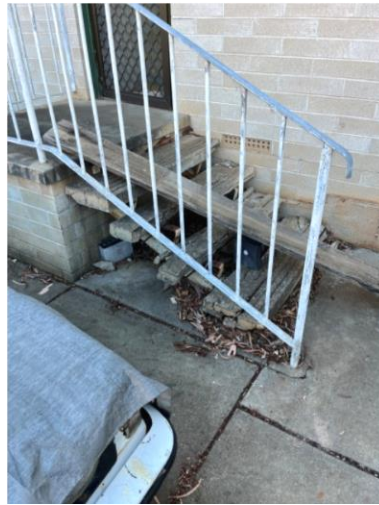
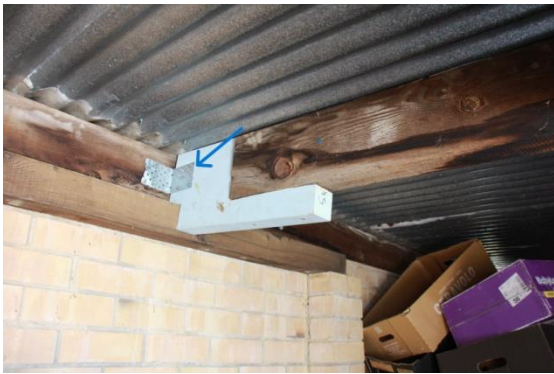
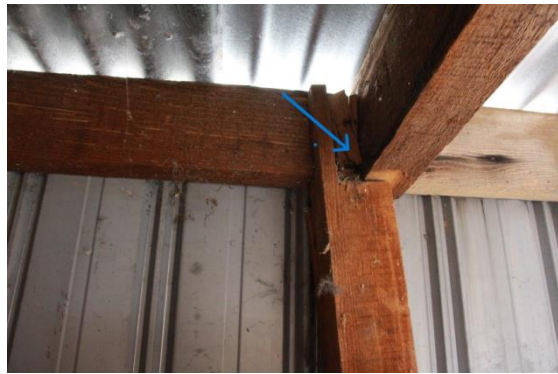
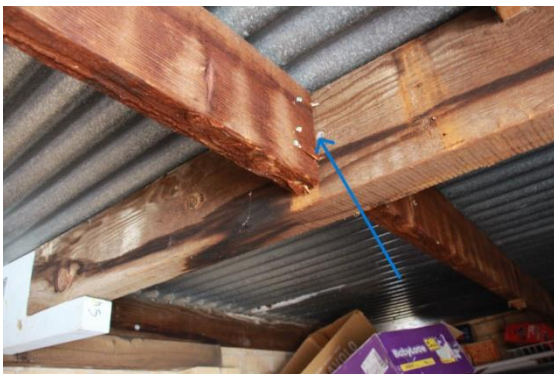
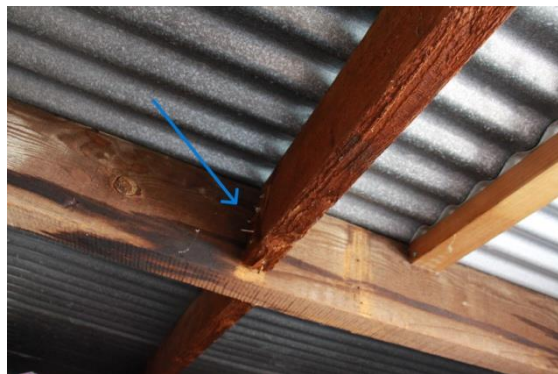
Details: 1. At the time of inspection a broken stairway was observed. It was a good example of concrete cancer. Concrete cancer is the common term used to describe number of factors which cause concrete construction to deteriorate. Generally, water penetration causes the concrete reinforcement to rust and expand, creating stresses on the surrounding concrete and in turn causing it to spall or break away. Treatment of concrete cancer can be expensive and the problem is likely to worsen over time, potentially leading to the development of major structural defects or safety hazards. A structural engineer should be appointed to provide estimates on the required works. 2. A few examples of poor workmanship and material defects were observed at the time of inspection in the roof cavity. This is a safety hazard and it might lead to a partial roof collapse. A correction by a licensed roofer or a carpenter is required ASAP to address the issue.
